Lessons Learned From the Construction of Upgrades to the NASA Glenn Icing Research Tunnel and Re-Activation Testing

David W. Sheldon, Charles R. Andracchio, and Thomas M. Krivanek
Glenn Research Center, Cleveland, Ohio

Prepared for the
39th Aerospace Sciences Meeting and Exhibit
sponsored by the American Institute of Aeronautics and Astronautics
Reno, Nevada, January 8–11, 2001

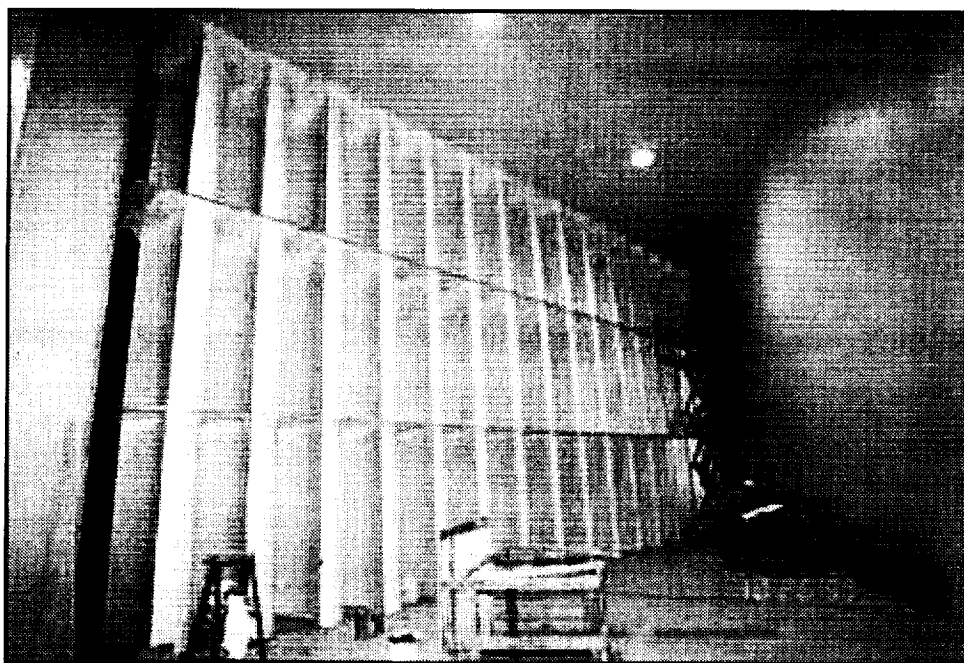
Figure 9.—Installation of the new fiberglass-composite turning vanes in Corner C. The horizontal tie plates between the vane segments help carry airloads directed outward along the corner diagonal. Socket connections at the ceiling provide for differential thermal expansion and contraction. (C-99-2287)

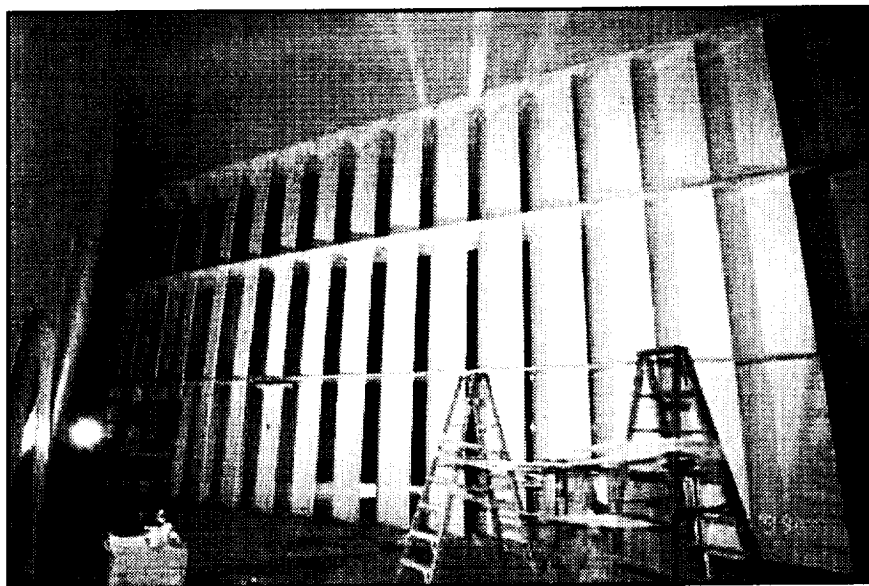
Figure 10.—View from the Stilling Chamber, looking upstream at the Corner D turning vanes. The lower segment of the seventh vane from the corner is removable, to provide access to the heat exchanger for a maintenance lift vehicle. (C-99-2285)

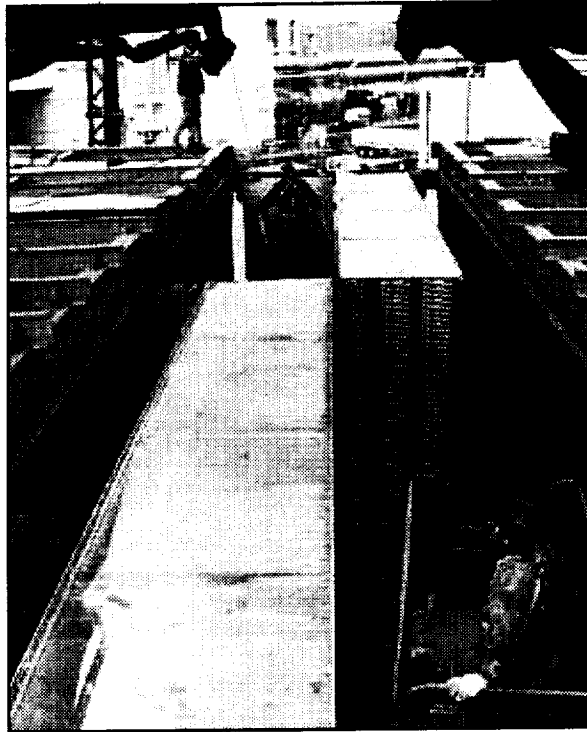
Figure 14.—View through the roof of the new C-D leg, showing the offset positions of the two heat exchanger units. The end turns in the coolant tubes are readily accessible for inspection and repair, without loss of active flow area for a corridor between units. (C-99-2178)

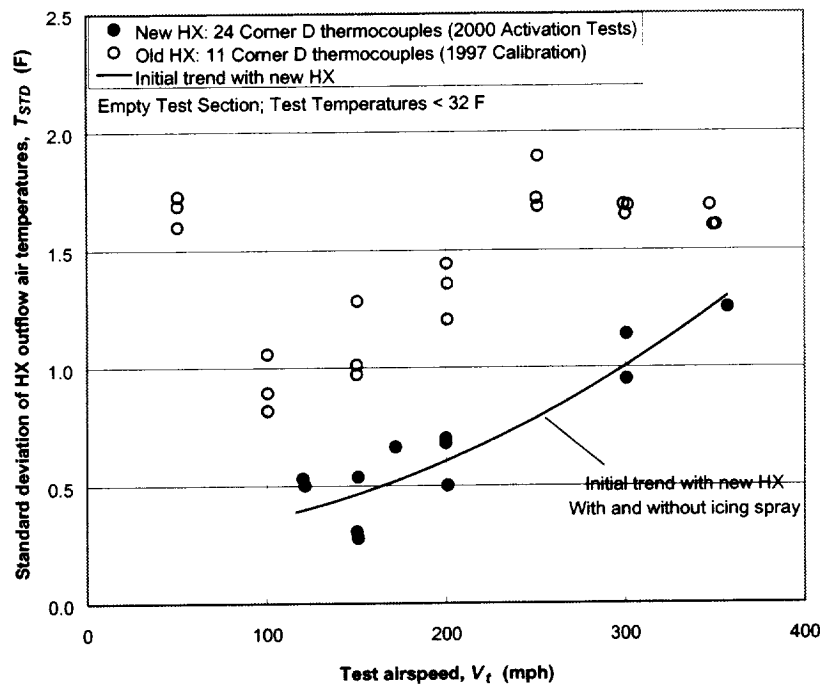
Figure 19 illustrates the improvements obtained in air temperature uniformity with the replacement HX. In this chart, the standard deviation of air temperature measured downstream of the HX, at the entrance to Corner D, is plotted versus the test airspeed. Deviations are approximately 0.6 F (0.3 C) less with the new HX than with the old, which is a reduction of approximately 50 percent at a test airspeed of 200 mph (89 m/s). Therefore, all PRVs were placed in a full-open condition pending their removal during a future

Figure 19.—Improvement in the uniformity of temperature in the outflow of the replacement heat exchanger, compared with the original heat exchanger. The standard deviation of the temperatures measured with the array of thermocouples in Corner D is used as the measure of uniformity.

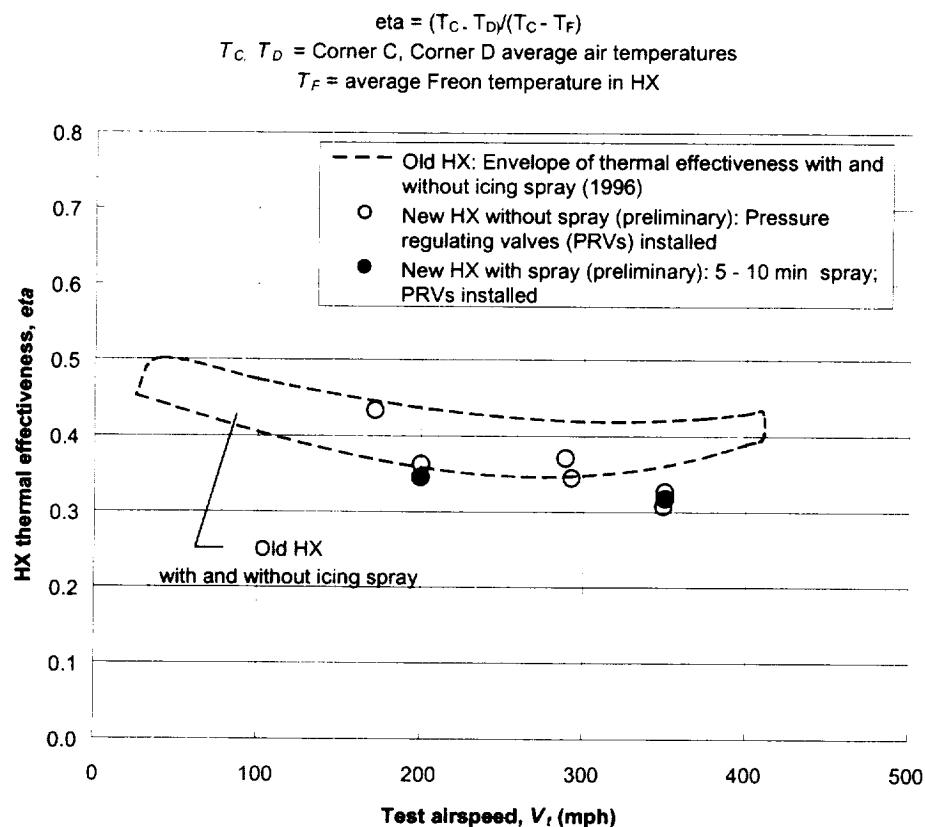
A quantitative measure of the cooling performance of a heat exchanger is its *thermal effectiveness*, defined as the ratio of the drop in air temperature across the HX to the difference between the inlet air temperature and the internal coolant temperature. In **Figure 21** some preliminary data on the thermal effectiveness of the new HX are compared with performance data for the original HX. As expected, the higher face (inlet) airspeeds into the new HX reduce its thermal effectiveness somewhat, compared to the W-shaped HX with its much lower face speeds for the same test airspeed. However, these preliminary data still indicate that the performance of the new HX under icing test conditions will meet design requirements and may be close to the design goal shown in **Figure 20** after the 24 PRVs are removed.

Figure 21.—Preliminary comparison of the measured thermal effectiveness of the new HX with that of the original HX.

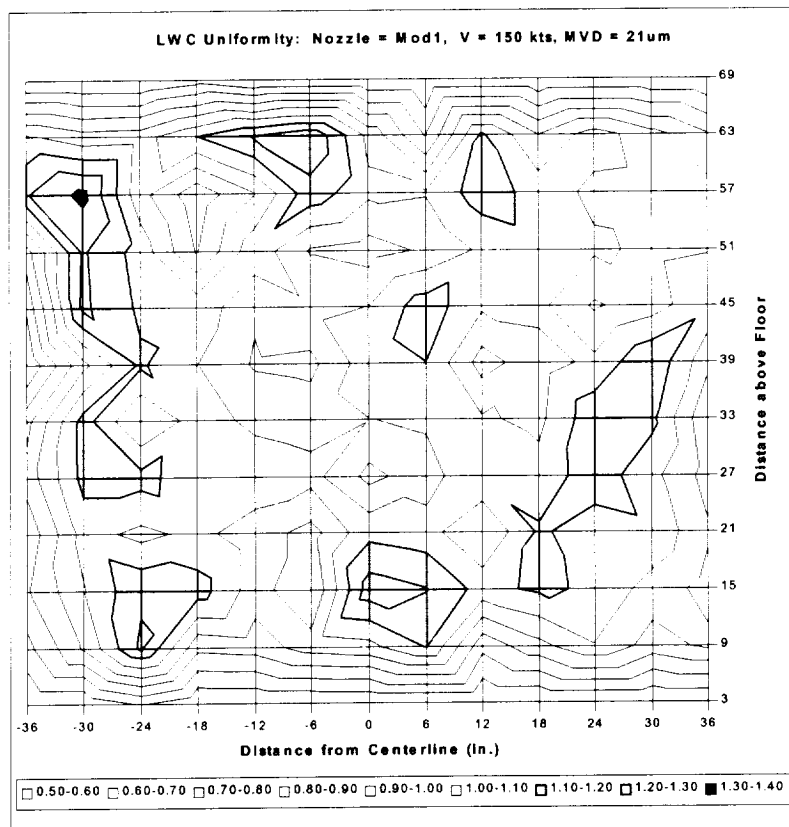
used to record ice thickness data. **Figure 23** is a typical contour plot of the variability of ice accretion across the Test Section, expressed as deviations of local thickness from the average thickness.

Figure 23.—Typical contour plot of the variability of ice accretion across a 6-ft by 6-ft (1.8-m by 1.8-m) zone in the middle of the Test Section.
